Digital Archeology with Drive-Independent Data Recovery: Now, With More Drive Dependence!

[ELEN E9002 Research Project Final Report – Summer 2011]

Christopher Fenton
chf2110@columbia.edu

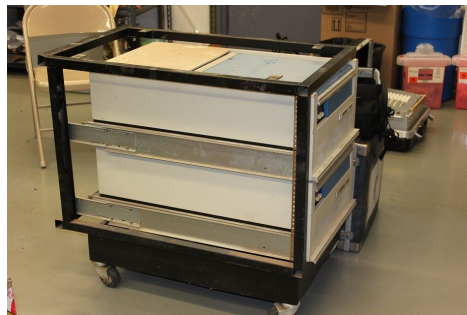
Figure 2: The two CDC 9762 Disk Drives shortly after arrival.

All of the equipment finally arrived on July 21st, allowing me to begin work. The first setbacks occurred almost immediately. Both drives had been sitting in some form of storage for at least two decades, and had acquired a fairly thorough coating of grime and/or filth. Disk drives are extremely precise, complicated electromechanical systems that effectively can't tolerate any kind of particulate contamination, so cleaning alone was going to be a challenge. Additionally, I had initially been working under the assumption that I had full documentation (including electrical schematics) for these drives [3], which would be an immense aid in debugging and repairing. Unfortunately, it appears that CDC produced multiple versions of the drive under the "CDC 9762" label. Both of the drives I was working with were manufactured in 1976, and appear to be CDC's earliest version of the drive. The documentation I had available belonged to a later version of the same drive being manufactured as late as 1985. Although the drive's mechanical parts were virtually

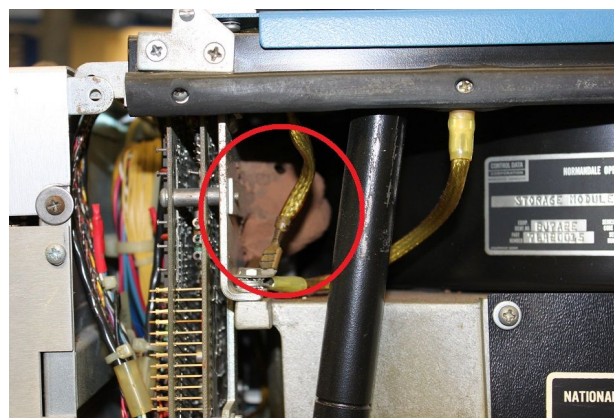
Both drives, when powered on, immediately asserted their internal 'fault' signals. The machine with the lowest number of hours on its lifetime counter (a mere 38,000 or so) was chosen for serious cleaning and debugging. A week or so of cleaning ensued before any serious electrical debugging was attempted. One of the largest problems encountered with the cleaning process was that the entire case of the drive was lined with 1/4" thick noise canceling foam that had degraded over time. Any contact with the foam would cause it to crumble into dust, something potentially disastrous if it were to contaminate the disk cavity, and ultimately all of it needed to be carefully removed. Additional problems were encountered from the large number of spiders that had taken up residence inside the disk drive, as well as a 3"-diameter (thankfully abandoned) "mud dauber" wasp nest [4] that had been constructed within the drive.

Figure 3: The spacious former home of a family of computer-savvy wasps

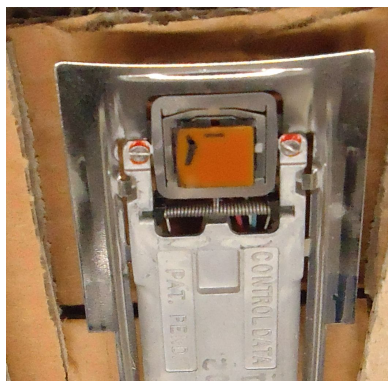
As a debugging feature, the coil and head assembly can be disconnected from the power amplifier and manually positioned over the disk, so long as the disk is spinning faster than 3000 RPM (the minimum speed required to allow the heads to fly). This procedure was attempted with the spare disk pack installed, and the drive actually asserted its 'ready' light, which I believe means it had successfully sensed valid servo data and completed its initialization process. Unfortunately, within 30 seconds of the heads being loaded a high-pitched whining noise began to be emitted from the drive, implying a potential head-to-disk contact was taking place. The drive was then powered down and the disk pack and heads were carefully examined. Thorough examination revealed that Head #4 on the drive (which reads the bottom surface of the lowest data platter) had 'crashed' into the disk surface and scraped away a concentric ring of oxide material, permanently damaging the platter. This is a good time to point out the advantages of not experimenting with your primary source material when performing digital archeology experiments!

Figure 5: Exposed read head following cleaning

The offending read head was removed from the drive, carefully cleaned to remove the layer of oxide that had been deposited on it, and set aside until further notice. At this point, the spare disk pack was once again loaded into the drive (now with only four read heads) and spun up, and the heads were then able to be successfully loaded without further incident.

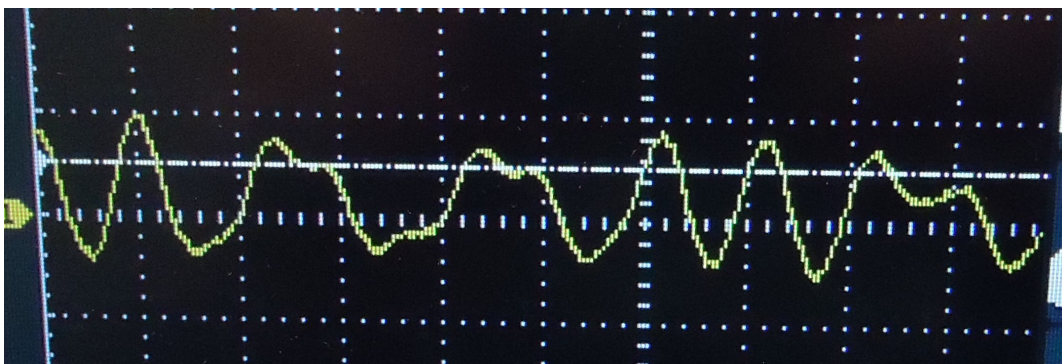
To test this hypothesis, our poor test disk pack was once again installed and spun-up, and an oscilloscope was used to observe the (remarkably intact!) analog data signal coming directly from the read amplifier.

Figure 6: Analog data snapshot clearly showing MFM-encoding pattern
